Sir Max Aitkin Museum, Isle of Wight

Location	Isle of Wight
Area	Building exterior
Date	October 2016
Products	Mapei Colorite, Mapei Planitop Mapei Silexcolor and Silancolor Ranges 3M Scotchkote 152LV
Requirements	Stopping sea water ingress into the fabric of the building while projecting the aesthetics and heritage of the building.

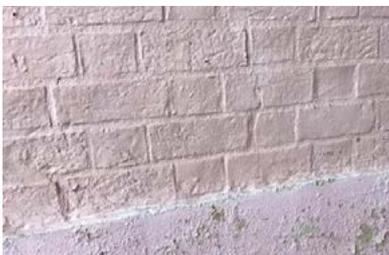
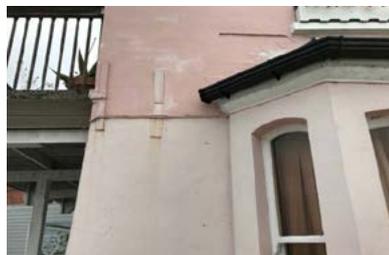
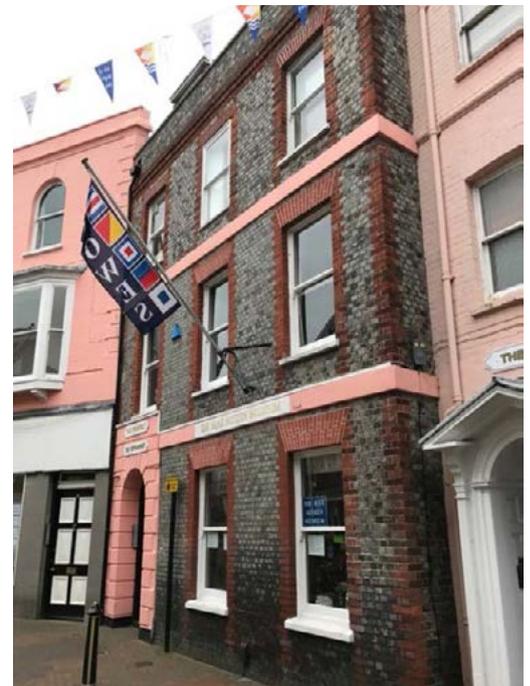
Firstly, we inspected a plinth that had been created from Lime render that had been painted with Dulux Weathershield, this product offers low micro porous properties therefore will not allow water to transmit through the coating and evaporate in the air. The building façade coating was in general in sound condition with only minor breakdowns of the film in localized spots.

Notwithstanding the issue of pigmentation of the coating, the major detractor from the overall appearance is the moisture issue emanating from capillary action of the sub base and “running rust” which is due to metal brace work breaking down due to insufficient priming and the effects of the environment and streaking.

The plinth detail which we are aware has been rendered with a lime based render is particularly effected as per the photos and is certainly due to moisture ingress and or rising moisture, as witnessed by efflorescence approx 1 metre high leaching out through the brick lines. This to be completely removed allowed to dry and treated with either Silex or Silan products.

1. Application of Colorite performance, clean down existing coating with high pressure washer, repair blown coating film, prime and overcoat. Treating all metal work with proprietary rust inhibitor after cleaning (see data sheet on Mapefer)

As discussed this would involve the removal of all existing coatings and the reinstatement with Mapei preparation products from the Planitop range. Planitop 100 /200 and on completion a change of coating type to Mapei Silexcolor Pittura or Silan Pittura Plus mineral coatings which have enhanced breathability combined with very robust water shedding properties.

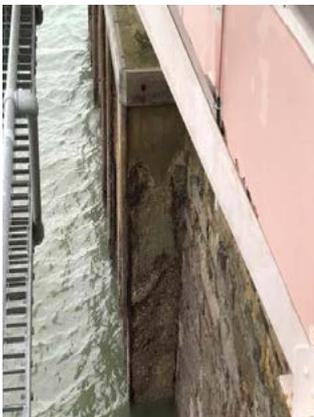
Image 1

1. We have witnessed the effects of chloride degradation to the standing buttresses as detailed in image 1.
2. There is evidence of tidal scour to the bases of the concrete columns and wash out of the concrete. See Image 2a and 2b.
3. The interlayer of brickwork shows evidence again of abrasion due to tidal and storm action, this manifests itself in image where the mortar lines are proud of the brick face.
4. Faces generally of the defence wall as seen in images have suffered the same level of degradation.
5. Our potential concern is the erosion due to rust of the I beam as per image, it is our opinion this must be investigated professionally. See Image 3.

1. The overall project the coating issue is relatively simple to address.
2. We strongly recommend that a corrosion/structural engineer be appointed with the remit of investigating the foundations, pillars and I beam before any attempt is made to address the aesthetics'.
3. On completion of his / her report a full package of remedial works to the base can be provided by Promain with an accompanying specification for the coatings issue.
