Sunnysands Railway Bridge and Beach Gates

(Completed May 2008)

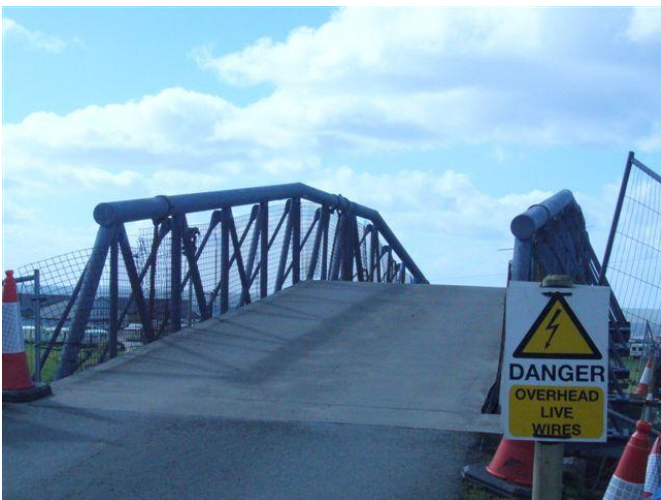
A view of the approach by road

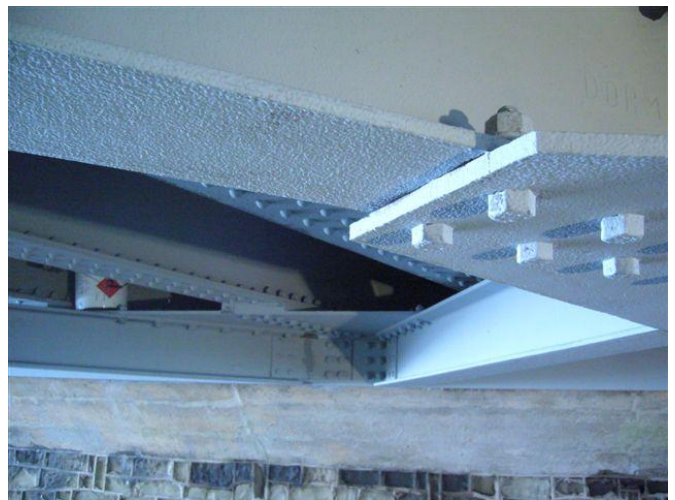
A view of some zingonised beams and fasteners

This was a total refurbishment project, and the entire structure was blast-cleaned and film-galvanised with Zinga. As the bridge is on the coast, the system used was: **Zinga**: 80µm DFT + **Alufer N**: 160µm DFT + **2K PU**: 60µm DFT **Zinga** (galvanising layer) + **Alufer N** (one component MIO PU sealer) + **2K polyurethane** (UV resistant finishing coat)

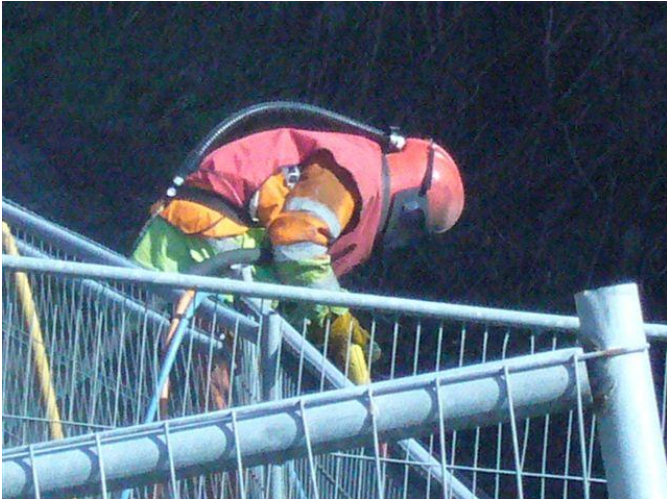
Blast-cleaning the bridge steelwork

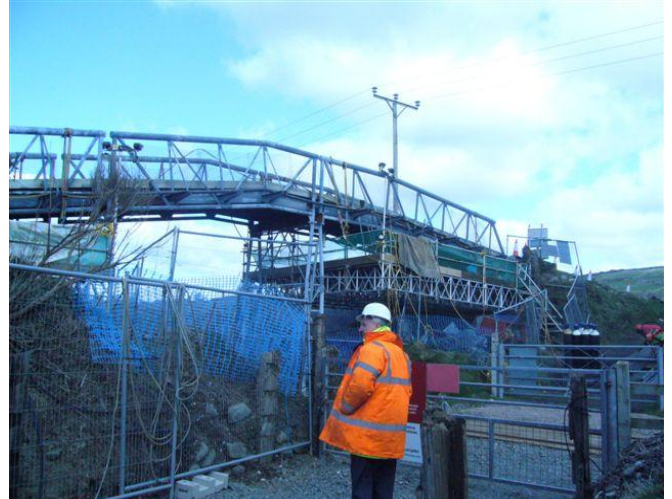
A view of the bridge during blast-cleaning operations

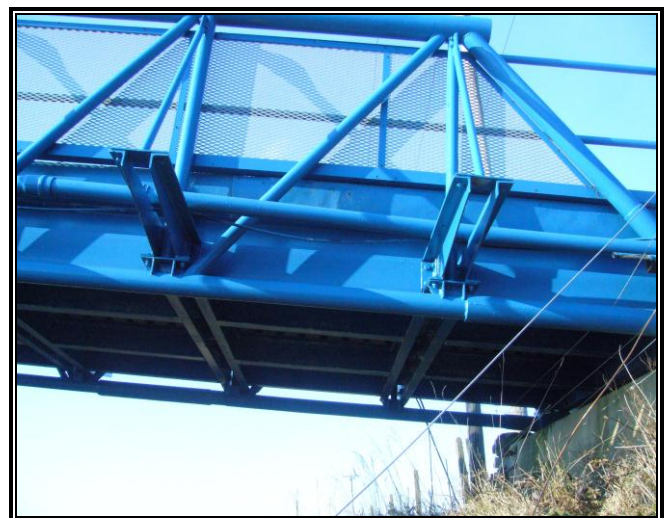
Two views of the completed bridge deck showing both the underside and the side of the deck

The above views illustrate that with the Zinga film-galvanising system the surface finish is as smooth as an automotive finish and any subsequent primers and topcoats will follow on to give a perfect, flaw-free finish every time.

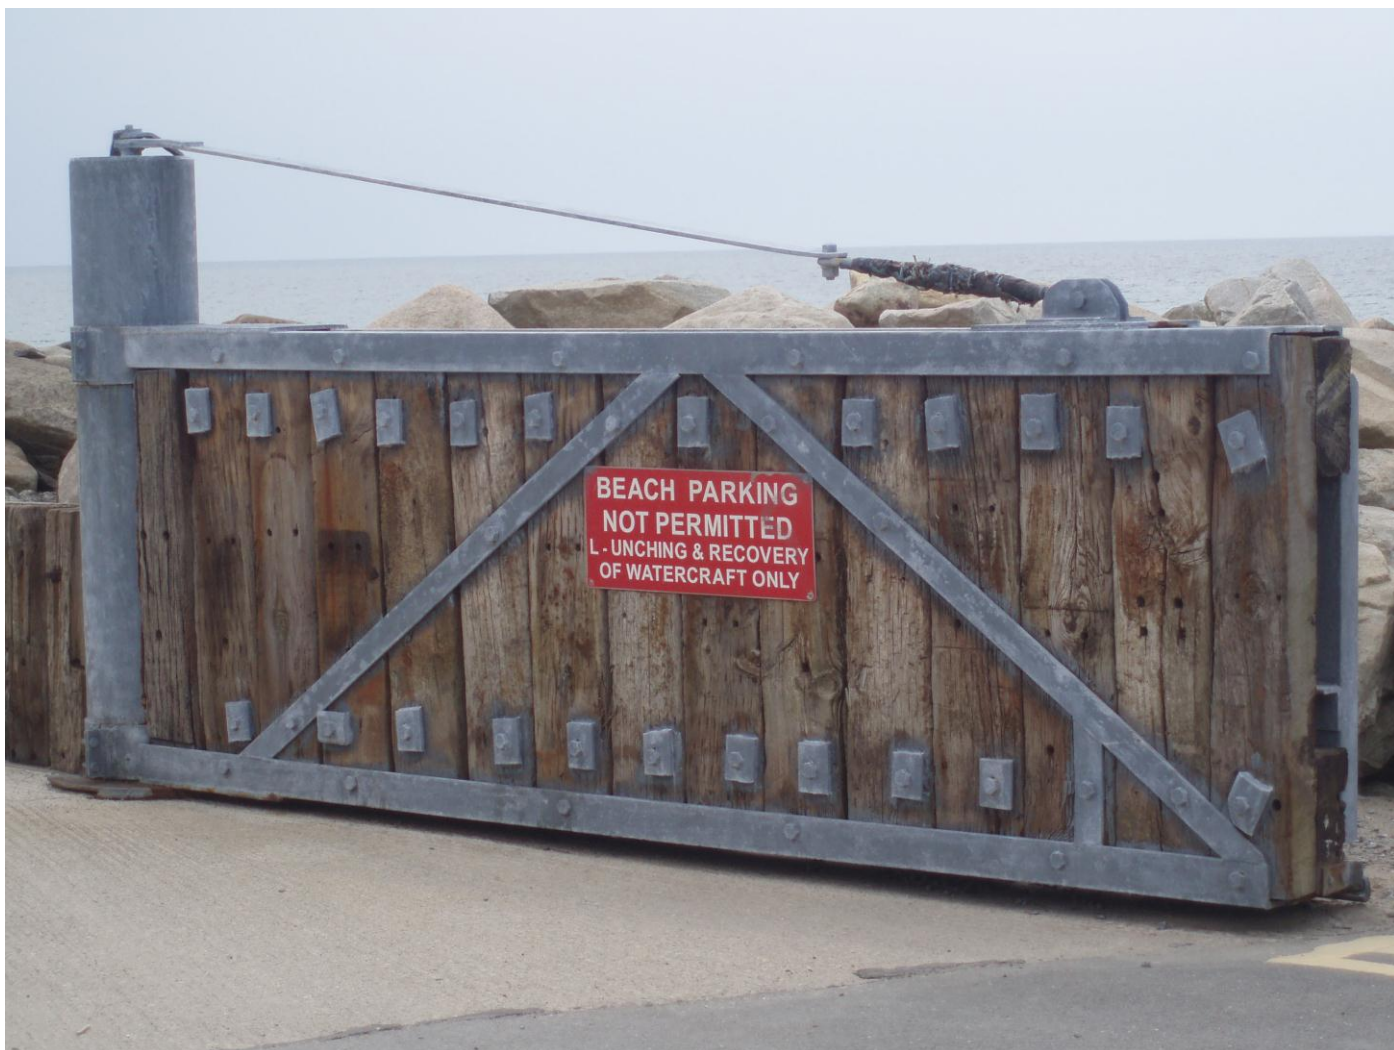
Sunnysands Beach Tide Gate

A view of the tide-gate and the heavy supporting pillar on the Sunnysands beach. An excellent reference for in-situ galvanising. The timbers were removed for blast-cleaning the steel gate-frame and application of the 150µm DFT Zinga. The steel timber-fastening plates were also film-galvanised with Zinga.

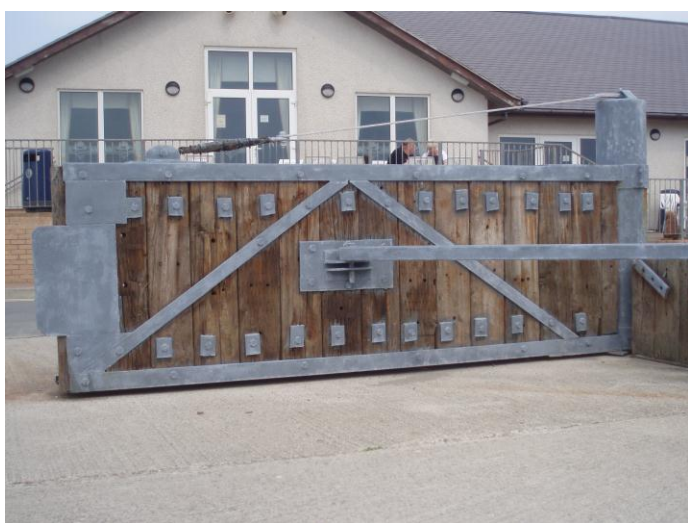
Another view of the tide-gate, showing the locking bar

This unique tide-gate prevents high tides from coming over the sand and spilling onto the public road. The locking bar is to provide additional support due to the hydraulic pressure generated at high tides from the waves.
