Coatings Research Institute

Procedure for the Fixing and Encapsulation of Asbestos Fibres on Weathered Asbestos Cement by Dakfill

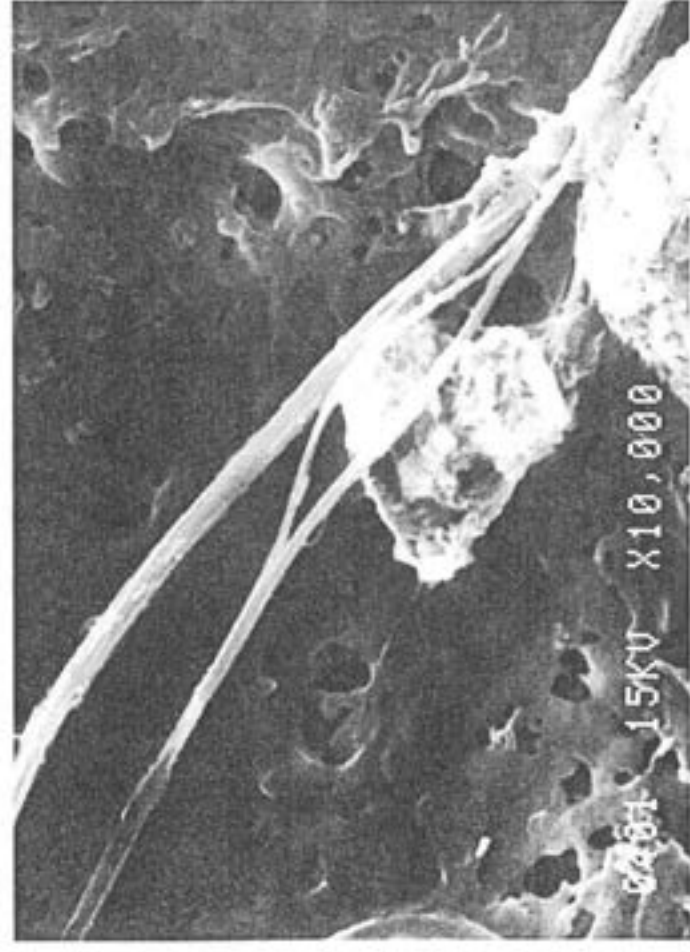
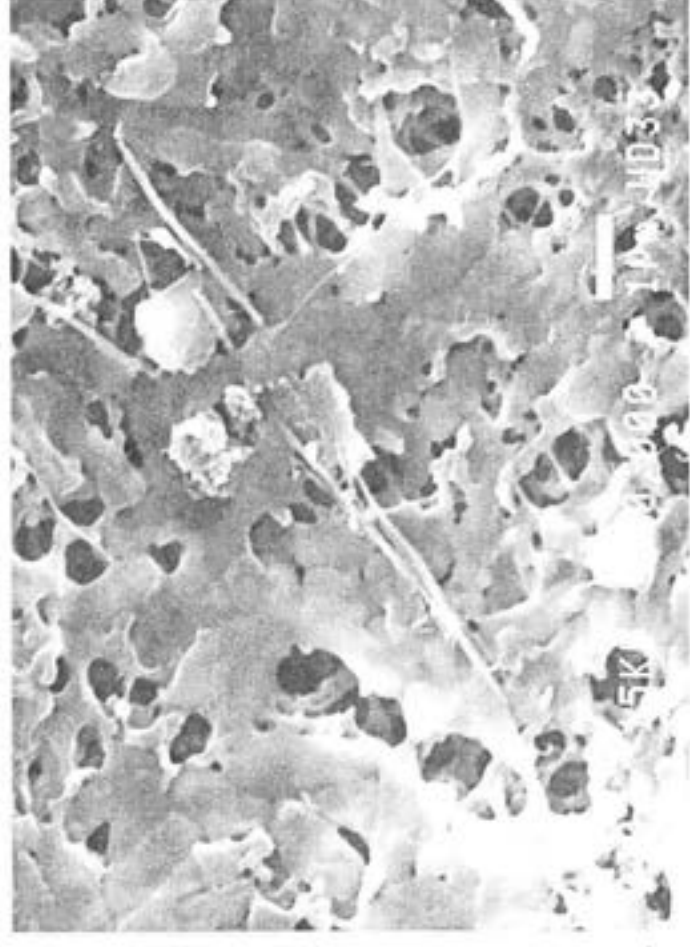
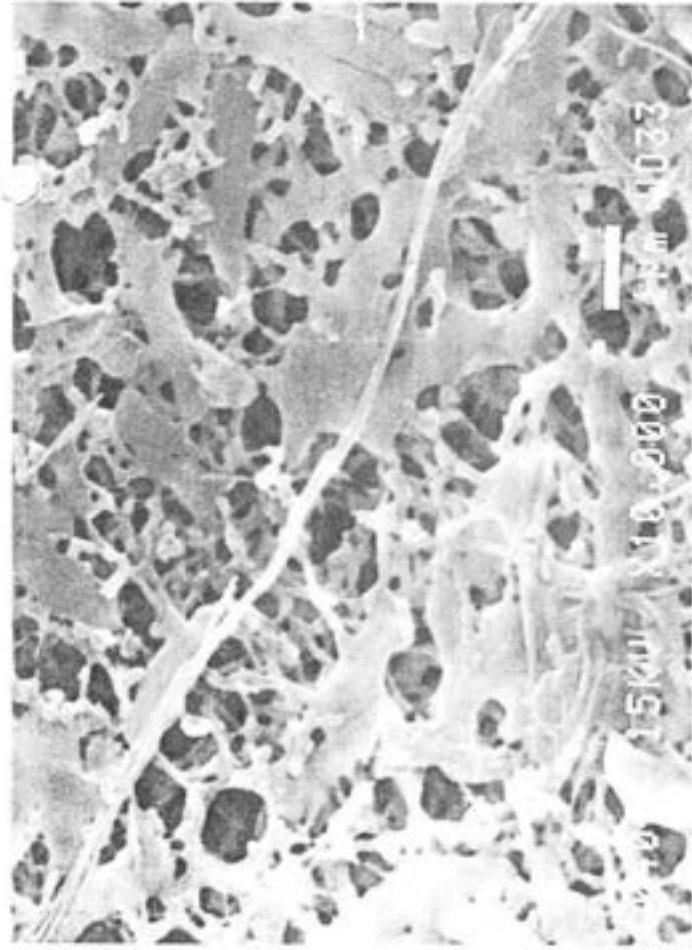
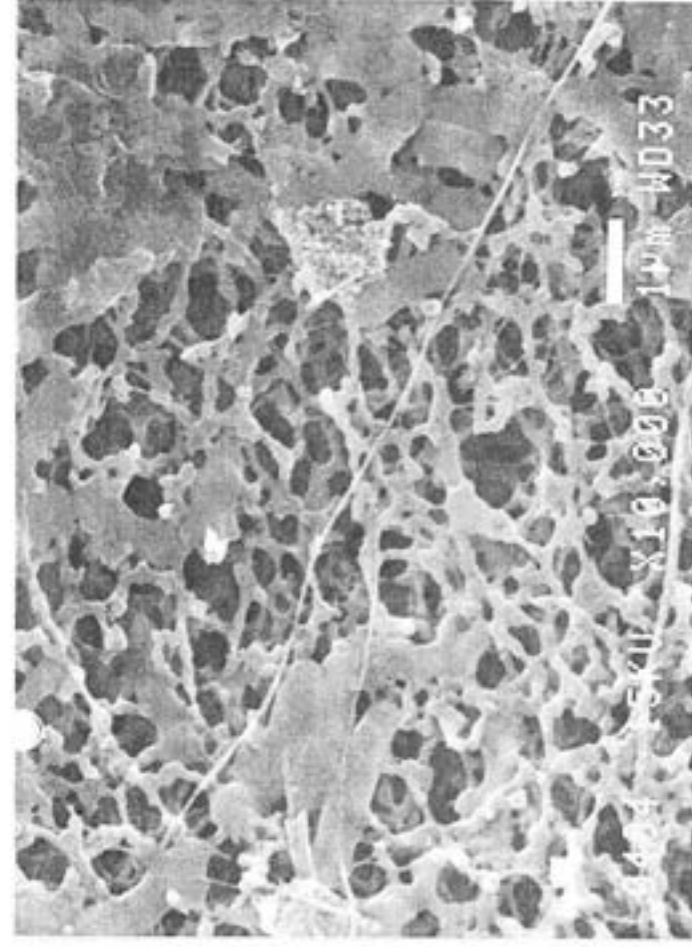
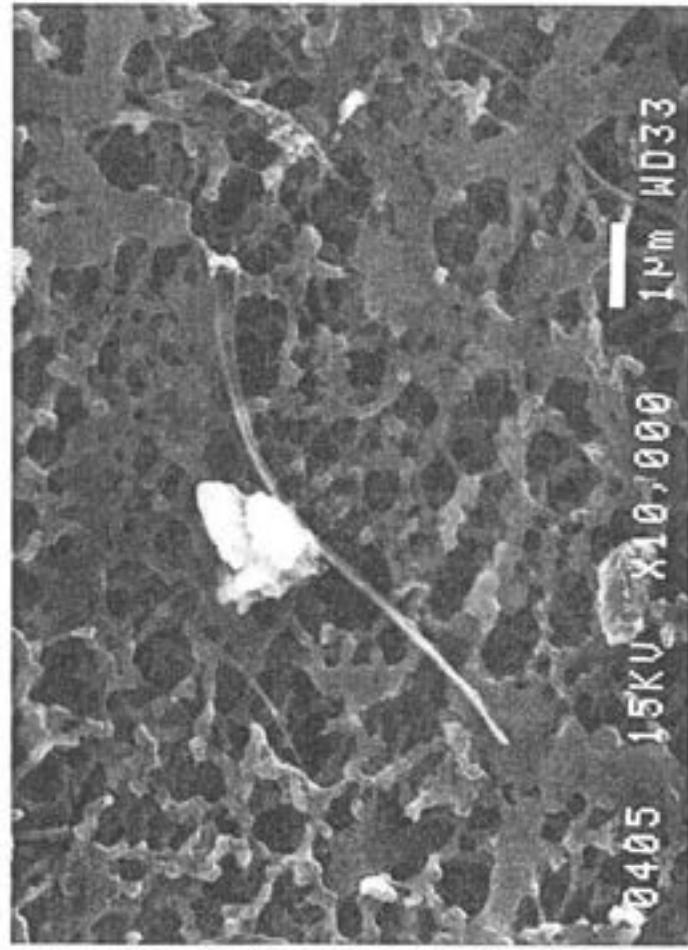
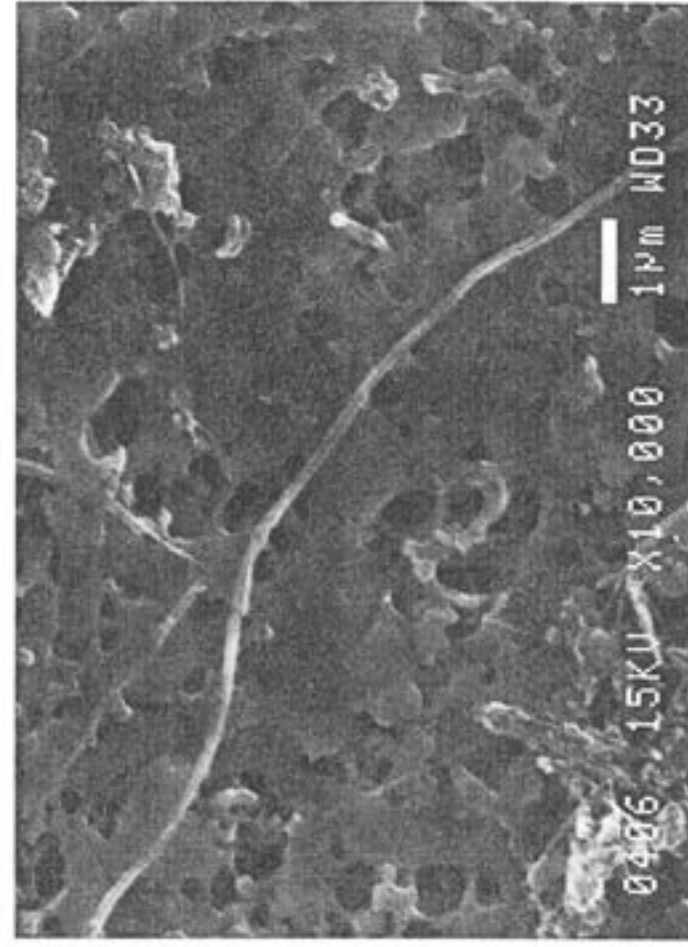
On the other hand, in the case of the naked panel, asbestos fibres were found on the filter. Photographs 0401, 0402, 0403, 0404, 0405 and 0406 give an idea of some fields. 200 fields of $108 \mu\text{m}^2$ each have thus been examined and 88 pieces of asbestos fibres have been found. When extrapolating from these data to the total filter surface, which is 19.62 m^2 in area, it can be put that $8 \cdot 10^6$ pieces of fibre have been carried away.

- 0010 paint system 1 after QUV
- 0100 paint system 1 after Kesternich
- 1000 paint system 1 after immersion in acid bath
- 0500 naked asbestos cement before Kesternich
- 5000 naked asbestos cement before immersion in acid bath
- 0400 naked asbestos cement after Kesternich
- 4000 naked asbestos cement after immersion in acid bath
- 1101 cross-section paint system 1
- 0401 asbestos fibre on diaphragm filter
- 0402 asbestos fibre on diaphragm filter
- 0403 asbestos fibre on diaphragm filter
- 0404 asbestos fibre on diaphragm filter
- 0405 asbestos fibre on diaphragm filter
- 0406 asbestos fibre on diaphragm filter
