CASE STUDY

Floor Preparation

Factory floor transformation

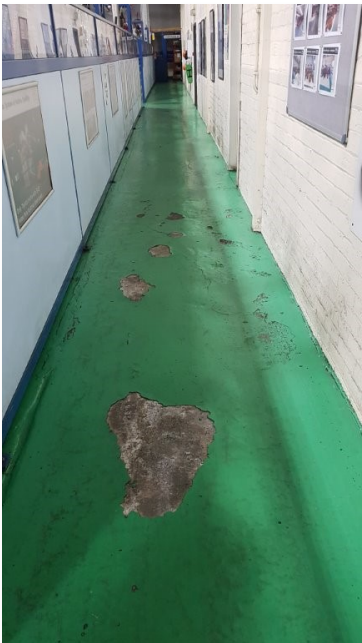
Before

Over the years, the paint thickness caused by over-coating in this old factory floor had built up.

The concrete floor was at a point where it was dangerous, a trip hazard, caused by the peeling paint layers.

In such cases, the best practice is to remove all existing coatings. This was done by diamond grinding the floor. After this, the surface was then ready to be re-coated.

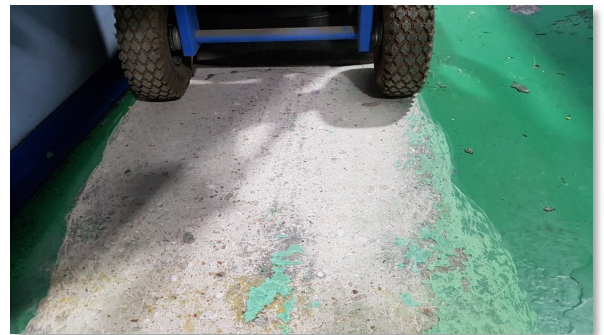
There were 100 square metres of walkways in the factory needing to be prepared and repainted.

Re-coating the surface was done using a roller, and a water based floor paint, Pegakote by Rust-oleum, supplied by our partners at Promain.
