Tank maintenance

For economical repair of corroded tank bottoms

Tank bottom repair using chopped glass fiber

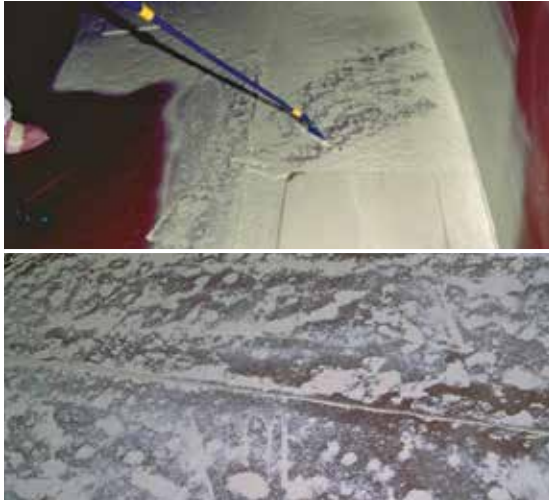
Level, uneven surfaces

In some situations, even after filling the pits, a caulking compound may be required to level the uneven areas. The *NOVAGUARD* 830 product can be applied to all weld seams, lap joints, shell side joints or other surface projections to provide a smooth surface transition. It is important that an even surface is provided by the caulking compound to assist in the application of the chopped fiber laminate to the tank bottom and joint areas.

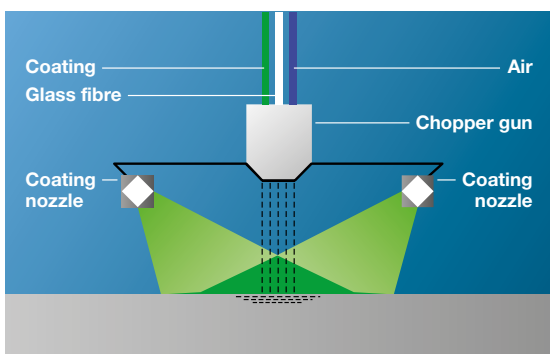
Chopped fiber application

After applying a primer (optional), filling the pits, leveling the uneven areas with caulking compound and stripe coating the weld seams, the tank bottom is ready for the application of the chopped fiber system. Glass roving is fed into the rear end of a chopper gun that cuts the roving into short pieces to about 2.54 cm (1 in) in length. The special spray apparatus ensures that the chopped fiber passes through the dual spray fans so that the fiber is encapsulated by the solvent-free coating before it lands on the steel surface.

To consolidate the glass fiber laminate, any trapped air is removed by rolling the coatings soon after application with a split-washer roller. After completion of the chopped fiber application, a final full coat of solvent-free finish, without chopped fiber, is applied to seal the laminate and give a smooth, easy-to-clean surface.

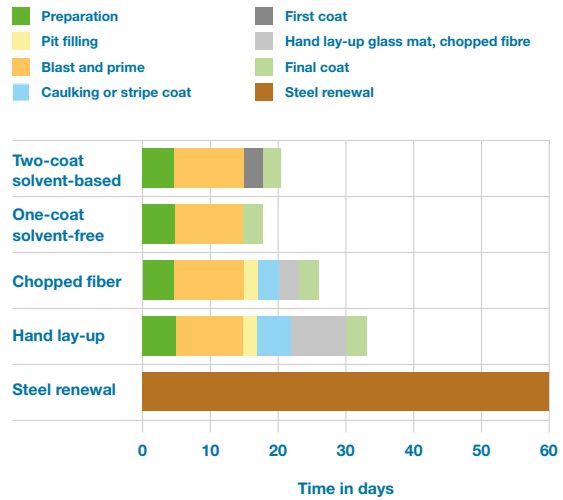
**Time for maintenance: 2,750 m² (9,022 ft²) tank
30 m (98.4 ft) diameter**

Compared to the amount of time the tank is out of service for various maintenance options, it is clear that repairing tank bottoms with a sprayed chopped fiber laminate is extremely economical, as demonstrated in the comparison below:

Using the chopped fiber system, the table above clearly indicates at least 50% saving in time compared to steel renewal. In addition, the material and application costs of the chopped fiber system are much lower, thereby giving significant cost savings to the tank farm operator.
