Benton Castle, Pembrokeshire

Location	Benton Castle, Pembrokeshire, Wales
Date	September 2013 - August 2014
Products	Silancolor Cleaner Plus Silancolor Plus Primer Silancolor Pittura Plus Mapesil AC - 100 White
Project Type	Restoration & Protection
Owner	Private Dwelling

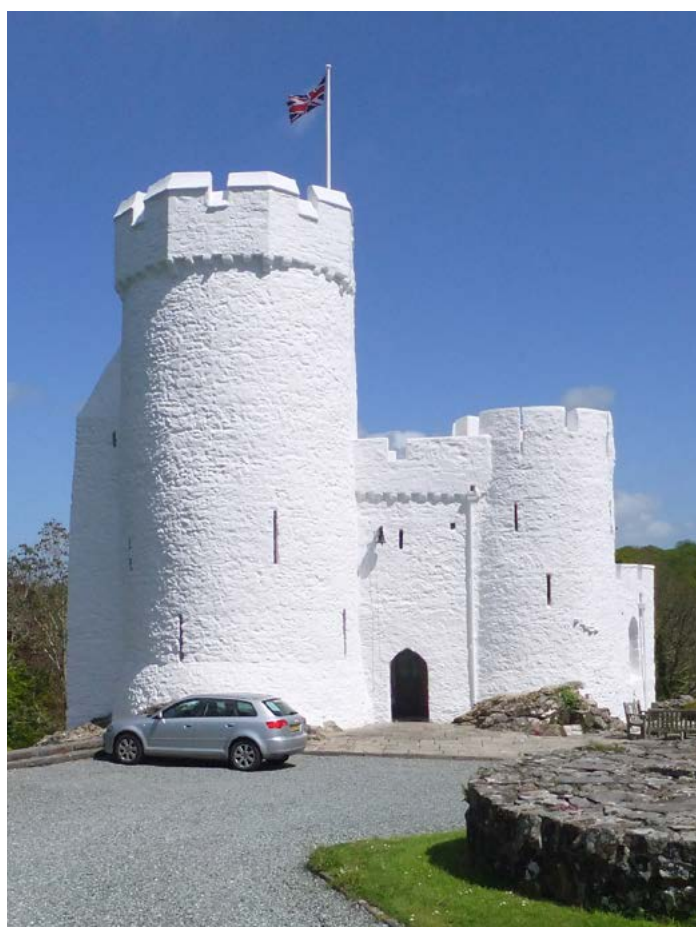
Approximately 800m² of Silanolor Cleaner Plus, a protective, water-based cleaning product was used to clean the surface, as the previous coating and mortar were damaged due to coastal weather from the estuary below, moss in the mortar and an algae infestation on the North face from adjacent trees.

external masonry walls were cleaned and a silicone primer was applied to the original substrate. The Mapei system offers a one-stop shop system approach to façade repair with all materials being available from a single source.

Mapei's Silanolor Plus Primer, a silicone resin based primer in water dispersion was then applied to the outer walls of the building to help regulate the absorption of the substrate and protect the wall surface from further chemical aggression.

To finish, a coat of Silanolor Pittura Plus, a water-repellent and breathable, protective decorative coating, was applied to provide a long-lasting protective coating to help prevent micro-organisms (such as mildew, mould and fungi) reforming on the external façade. In addition, Mapei's Mapesil AC a solvent-free, acetic cross-linking, mould resistant silicone sealant, was used for the restoration of the cracks in the external façade.
