Sir Max Aitkin Museum, Isle of Wight

Location	Isle of Wight
Area	Building exterior
Date	October 2016
Products	Mapei Colorite, Mapei Planitop Mapei Silexcolor and Silancolor Ranges 3M Scotchkote 152LV
Requirements	Stopping sea water ingress into the fabric of the building while projecting the aesthetics and heritage of the building.

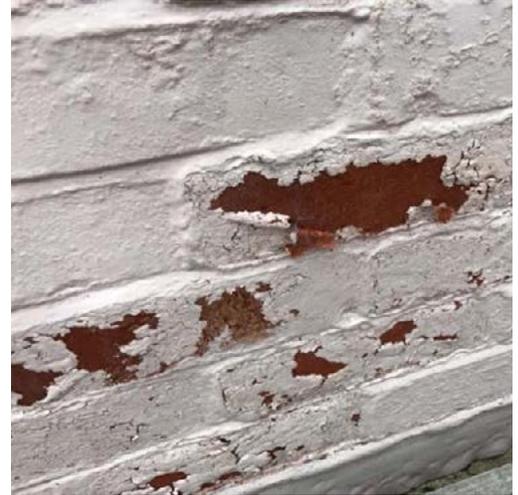
Image 1

1. We have witnessed the effects of chloride degradation to the standing buttresses as detailed in image 1.
2. There is evidence of tidal scour to the bases of the concrete columns and wash out of the concrete. See Image 2a and 2b.
3. The interlayer of brickwork shows evidence again of abrasion due to tidal and storm action, this manifests itself in image where the mortar lines are proud of the brick face.
4. Faces generally of the defence wall as seen in images have suffered the same level of degradation.
5. Our potential concern is the erosion due to rust of the I beam as per image, it is our opinion this must be investigated professionally. See Image 3.

1. The overall project the coating issue is relatively simple to address.
2. We strongly recommend that a corrosion/structural engineer be appointed with the remit of investigating the foundations, pillars and I beam before any attempt is made to address the aesthetics'.
3. On completion of his / her report a full package of remedial works to the base can be provided by Promain with an accompanying specification for the coatings issue.
