Old Castle, Leicester

Products applied:	Centrecoat R10 Paint Stripper
Location:	Leicester.
Date:	Autumn 2016
Contractor:	Beech Restoration
Substrate:	Brick
Project Work Undertaken:	Removal of all previous paint coatings to allow refurbishment of internal brick walls.

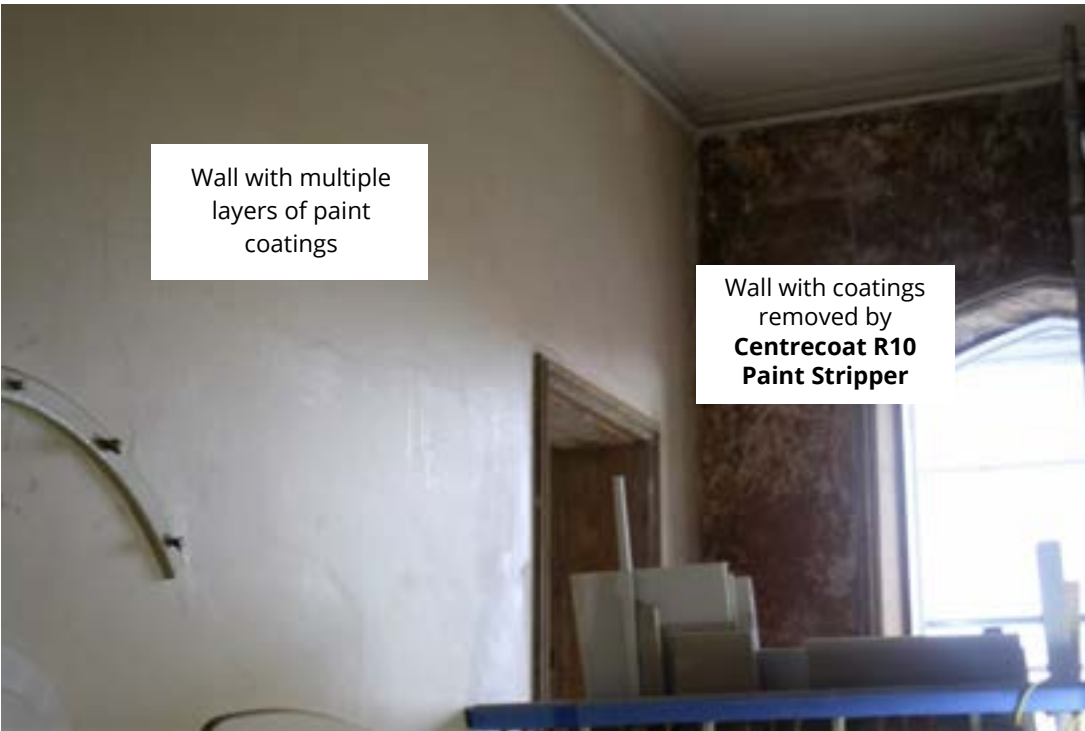
Wall with multiple layers of paint coatings

Wall with coatings removed by **Centrecoat R10 Paint Stripper**

To refurbish the main rooms it was necessary to remove years and years of paint coatings from the internal walls. To achieve this sympathetically, **Centrecoat R10 Paint Stripper** was selected. The product was applied to a wall at a time, sheeting it over and leaving overnight. This allowed all the layers of paint to soften allowing easy removal and safe disposal.
