Products applied:	<a href="#">Centrecoat R13 Rust Remover</a>
Location:	Car Park, Guildford, Surrey
Date:	2021
Ownership:	Private
Contractor:	Abacus
Substrate:	Cast Concrete

### Summary

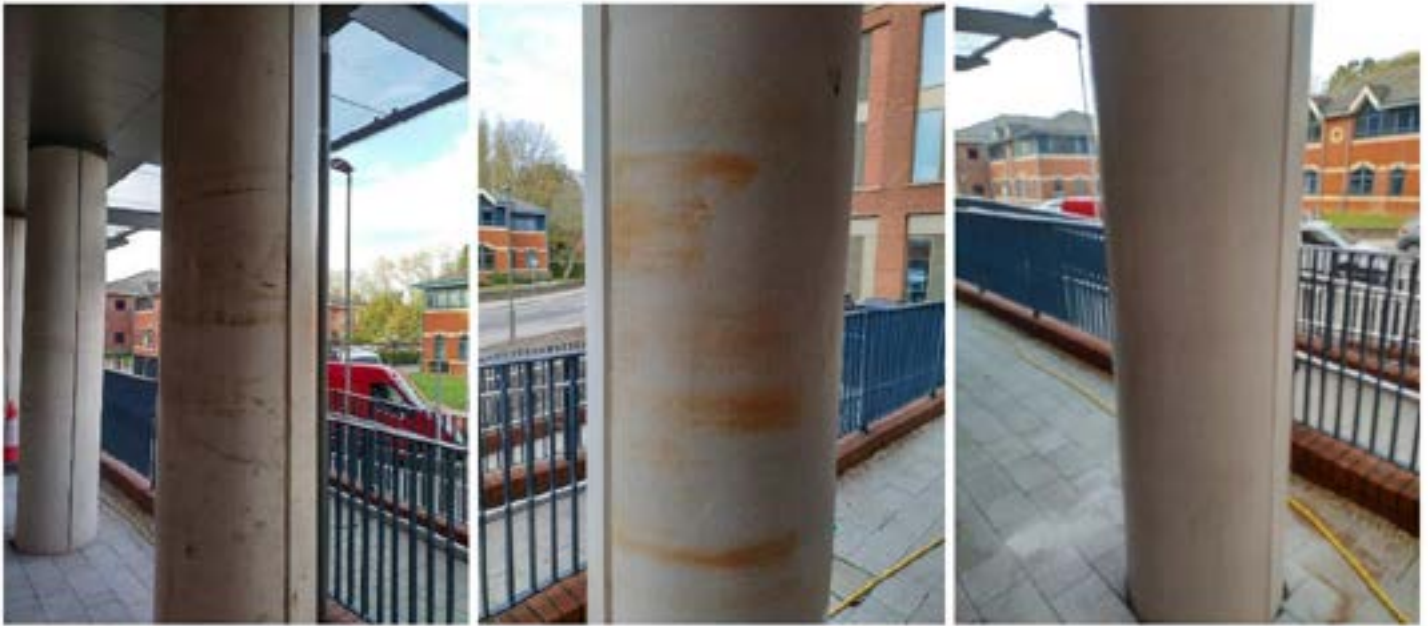
Before

After

Various unsightly rust staining on cast concrete columns in a car park required cleaning. [Centrecoat R13 Rust Remover](#) was applied to the affected areas, and after a 15 minute dwell time the surface was thoroughly rinsed with cold water.

All rust stains were removed as well as associated soiling, making the surface looking as clean as 'new'.
