Old Castle, Leicester

Products applied:	Centrecoat R10 Paint Stripper
Location:	Leicester.
Date:	Autumn 2016
Contractor:	Beech Restoration
Substrate:	Brick
Project Work Undertaken:	Removal of all previous paint coatings to allow refurbishment of internal brick walls.

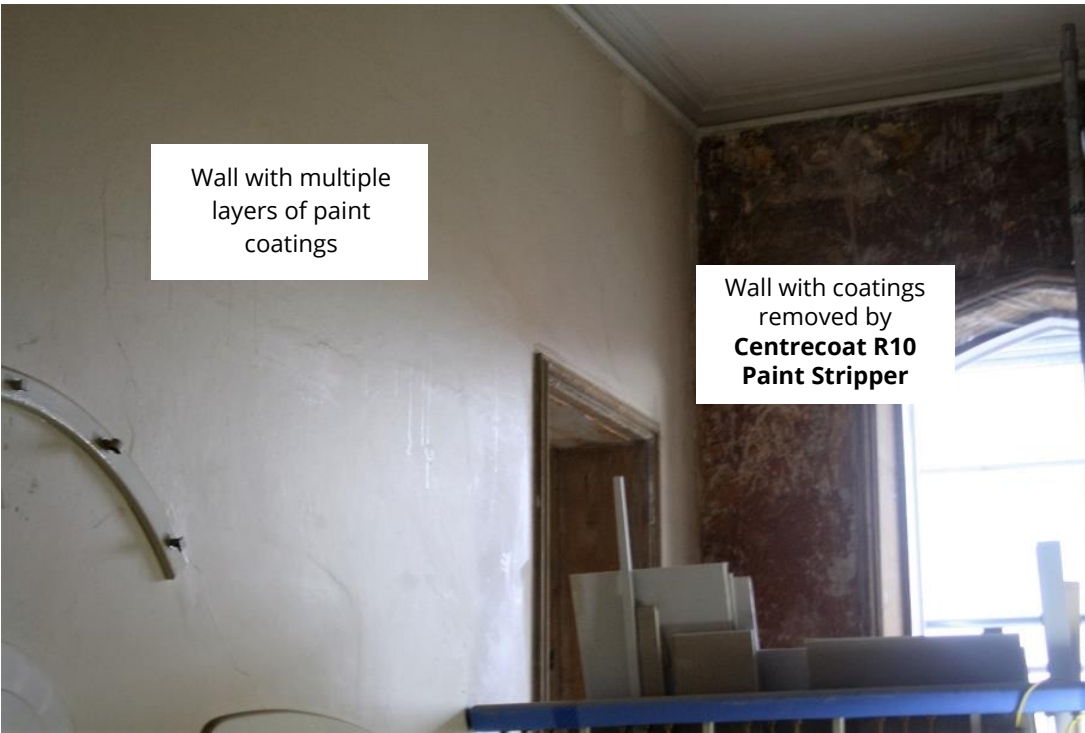
Wall with multiple
layers of paint
coatings

Wall with coatings
removed by
**Centrecoat R10
Paint Stripper**

To refurbish the main rooms it was necessary to remove years and years of paint coatings from the internal walls. To achieve this sympathetically, **Centrecoat R10 Paint Stripper** was selected. The product was applied to a wall at a time, sheeting it over and leaving overnight. This allowed all the layers of paint to soften allowing easy removal and safe disposal.

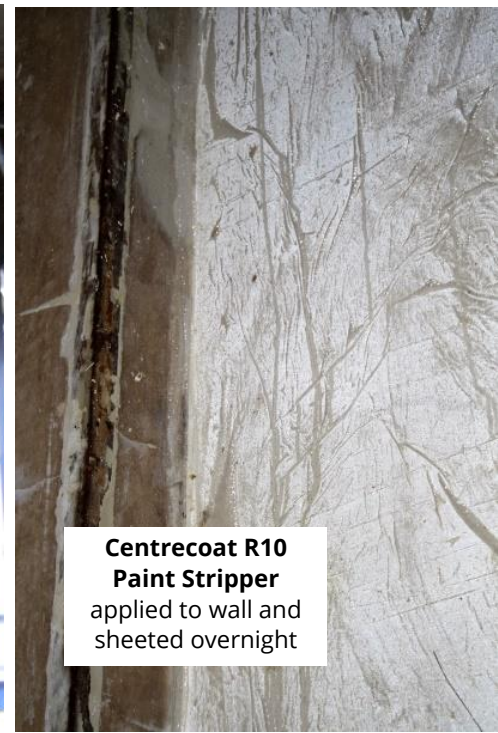
**Centrecoat R10
Paint Stripper**
applied to wall and
sheeted overnight
